**Tree Survey Report****Client:** Hill & Moor Parish Council**Site:** Hill & Moor council land**Inspection Date:** 06.08.2026**Surveyor:** Nick Bolton  
(BA Hons BSc Hons MArborA MICFor RCarborA)**Inspection  
Timeframe:** 28 months

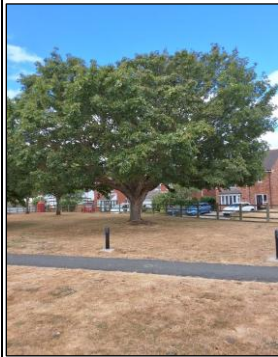
| Ref. | Other Reference | Species | Description | Measurements | Survey Notes | Likelihood of Failure | Risk Rating | Recommendations | Photo |
|---|---|---|---|---|---|---|---|---|---|
| <a href="#">T001</a> | 3273 | Norway maple<br>( <i>Acer platanoides</i> ) | Target # - playground<br>- Within drip line.<br>- Occupancy - Rare(1).<br>Target # - road<br>- Within drip line.<br>- Occupancy - Occasionally(2).<br>- Not practical to move the target.<br>- Not Practical to restrict access to the target zone. | Height (m): 12<br>Crown Radius (m): 8<br>DBH (cm): 70<br>Life Stage: Mature<br>Life Exp.: 10+ Years | * Load Factors<br>Wind Exposure: Full.<br>Crown Size: Large.<br>Crown Density: Sparse.<br>Interior Branches: Normal.<br>* Crown and Branches<br>Mature tree on west side of site with canopy almost over road. Thinning canopy with dieback in upper crown and small leaves. Black bleed spots on stem indicate root stress, possibly phytophthora but could also be a stress response to weather conditions following prolonged period of heat and no rain.<br>Main concern(s): Deadwood failure | Possible | Low - Monitor | Advisory only. No action required.<br>Timescale: No Action | |

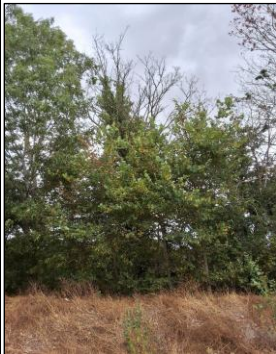
| Ref. | Other Reference | Species | Description | Measurements | Survey Notes | Likelihood of Failure | Risk Rating | Recommendations | Photo |
|---|---|---|---|---|---|---|---|---|---|
| <a href="#">T002</a> | 3274 | Sycamore<br>( <i>Acer pseudoplatanus</i> ) | Tree in hedge.<br>Target # - footpath<br>- Within 1x tree height.<br>- Occupancy - Rare(1).<br>- Not practical to move the target.<br>- Not Practical to restrict access to the target zone. | Height (m): 8<br>Crown Radius (m): 3<br>DBH (cm): 20<br>Stems: 2<br>Life Stage: Early Mature | * Load Factors<br>Wind Exposure: Partial.<br>Crown Size: Medium.<br>Crown Density: Sparse.<br>Interior Branches: Few.<br>* Crown and Branches<br>Dead tree in wide hedgerow on eastern boundary.<br>Other trees and vegetation offers protection factors to footpath users.<br>Main concern(s): tree failure | Possible | Low - Monitor | Advisory only. No action required.<br>Timescale: No Action | |

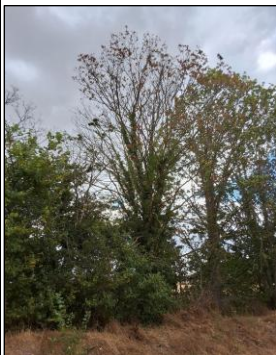
| Ref. | Other Reference | Species | Description | Measurements | Survey Notes | Likelihood of Failure | Risk Rating | Recommendations | Photo |
|---|---|---|---|---|---|---|---|---|---|
| <a href="#">T003</a> | 3275 | Sycamore<br>( <i>Acer pseudoplatanus</i> ) | Tree in hedge.<br>Target # - footpath<br>- Within 1x tree height.<br>- Occupancy - Rare(1).<br>- Not practical to move the target.<br>- Not Practical to restrict access to the target zone. | Height (m): 10<br>Crown Radius (m): 4<br>DBH (cm): 30<br>Life Stage: Early Mature<br>Life Exp.: <10 years | * Load Factors<br>Wind Exposure: Partial.<br>Crown Size: Medium.<br>Crown Density: Sparse.<br>Interior Branches: Few.<br>* Crown and Branches<br>Poor condition tree in wide hedgerow on eastern boundary. Condition is possibly a stress response to prolonged period of hot weather with no rain.<br>Other trees and vegetation offers protection factors to footpath users.<br>Main concern(s): tree failure | Possible | Low - Monitor | Advisory only. No action required.<br>Timescale: No Action | |

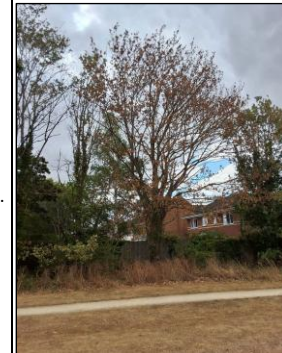
| Ref. | Other Reference | Species | Description | Measurements | Survey Notes | Likelihood of Failure | Risk Rating | Recommendations | Photo |
|---|---|---|---|---|---|---|---|---|---|
| <a href="#">T004</a> | 3276 | Sycamore<br>( <i>Acer pseudoplatanus</i> ) | <p>Tree in hedge.</p> <p>Target # - footpath</p> <ul style="list-style-type: none"> <li>- Within 1x tree height.</li> <li>- Occupancy - Rare(1).</li> <li>- Not practical to move the target.</li> <li>- Not Practical to restrict access to the target zone.</li> </ul> <p>Target # - neighbouring dwelling</p> <ul style="list-style-type: none"> <li>- Within drip line.</li> <li>- Occupancy - Constant(4).</li> <li>- Not practical to move the target.</li> <li>- Not Practical to restrict access to the target zone.</li> </ul> | <p>Height (m): 15</p> <p>Crown Radius (m): 6</p> <p>DBH (cm): 30</p> <p>Stems: 3</p> <p>Life Stage: Mature</p> <p>Life Exp.: 10+ Years</p> | <p>* Load Factors</p> <p>Wind Exposure: Partial.</p> <p>Crown Size: Medium.</p> <p>Crown Density: Sparse.</p> <p>Interior Branches: Few.</p> <p>* Crown and Branches</p> <p>Poor condition tree on eastern boundary, with canopy over neighbouring property garden.</p> <p>Canopy on east side has been pruned by neighbour to boundary line. Condition is possibly a stress response to prolonged period of hot weather with no rain.</p> <p>Main concern(s): tree failure</p> | Possible | Low - Monitor | Advisory only. No action required, but tree should be reviewed in summer 2027 to allow assessment of condition. Timescale: 06-Aug-2027 (12 Months) | |
